2016 Toyota Camry

VIN / chassis
JTNB11HK4G3000123

Inspected
2026-11-10

Report CQ-2026-000125 · Inspection INS-2026-LA-000125
This report reflects a physical inspection by a ChassiQ field officer on the date shown. The photos and checks are held on file.

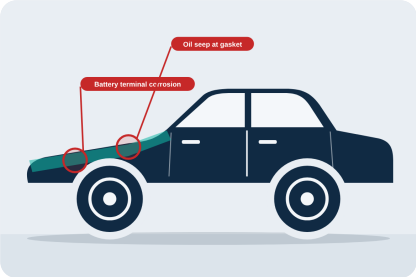
Oil leaks

MINOR DEFECT — Engine

Light oil seep at the valve cover gasket. No drips on the ground. Monitor and reseal at next service.

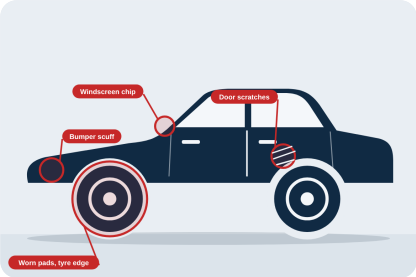
Scratches

MINOR DEFECT

Three light scratches on the rear left door, through the clear coat. Polishing will not remove all of them.
